## New Look for an Old Light Part One

By Wayne Sapulski

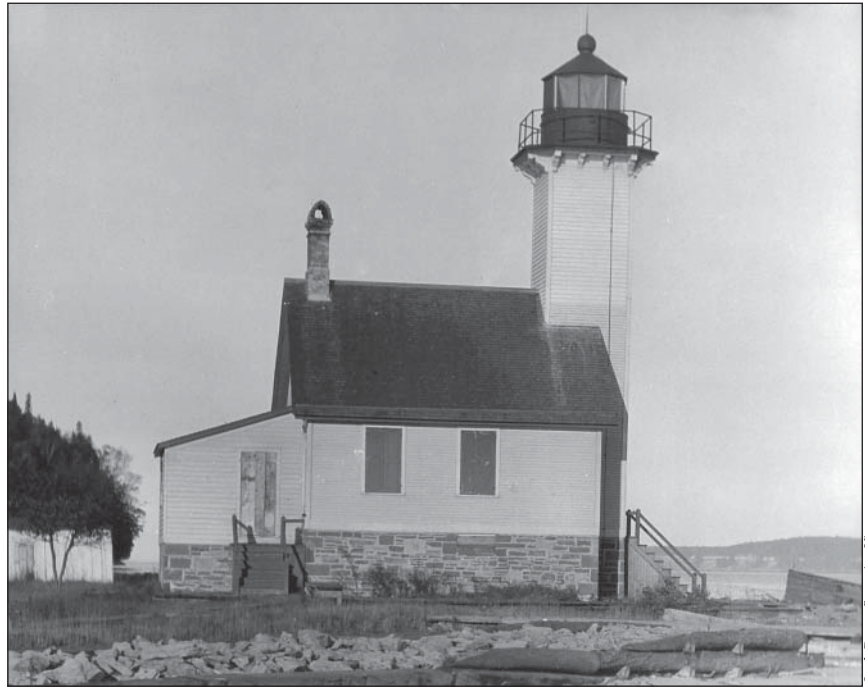
**Grand Island East Channel Light c.1908. The kitchen/wood shed with the lean-to roof at the back of the building, as well as the chimney, have been gone for decades**

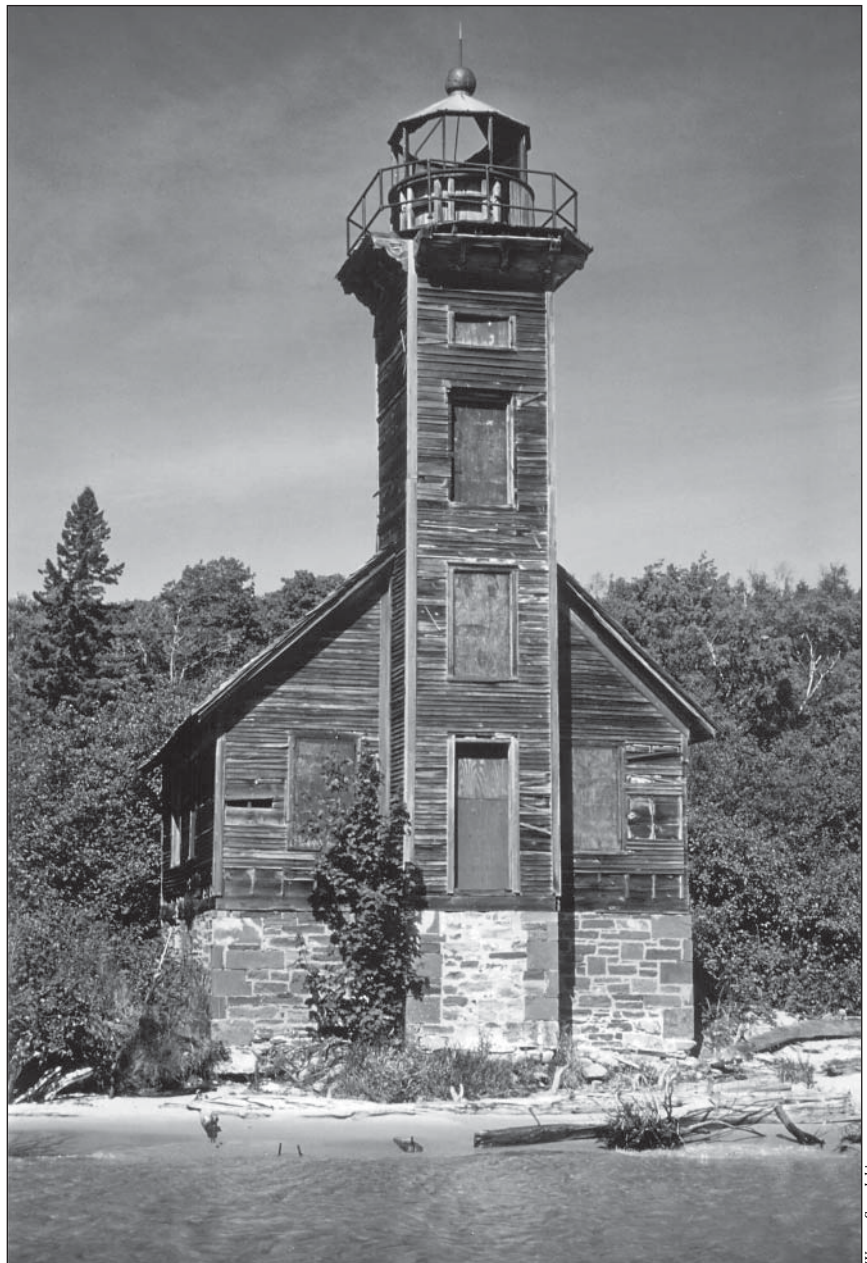
time reducing it to an empty shell in serious need of internal support. What white paint there had been slowly fell away causing the weathered wooden siding to take on a dark gray appearance. Even in its semi-ruinous state, GIECL became an obligatory tourist stop on the Pictured Rock Cruises out of Munising, making it one of the most photographed lighthouses in Michigan.

*The sad state of Grand Island East Channel Light before improvements, September 2000*

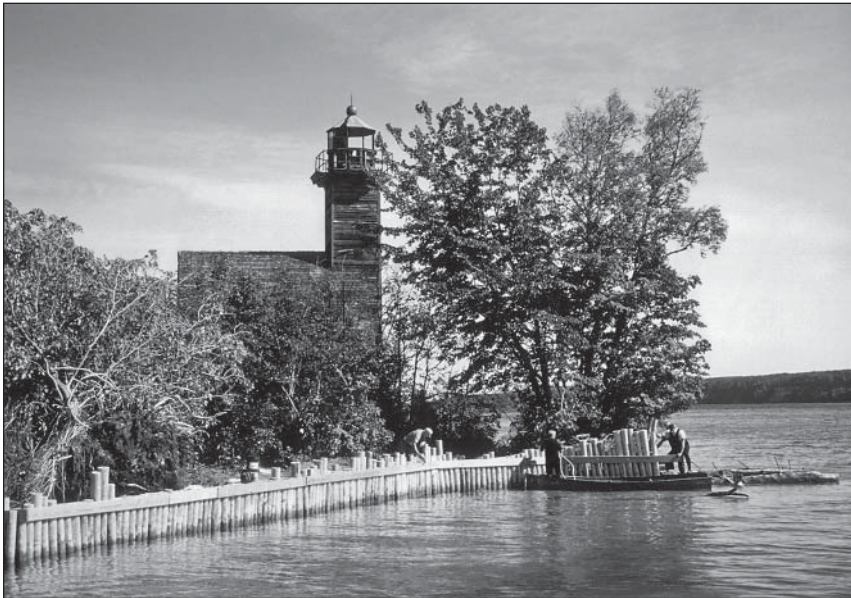
***Grand Island East Channel Light Rescue Project volunteers at work on the breakwater, September 2000***

The first order of business, which commenced in the summer of 2000, was the construction of a protective breakwater for several hundred feet along the shoreline in front of the lighthouse. Working in waste-deep cold water, donated cedar posts were sunk vertically into the shoreline by volunteers using a water jet to displace the sand. The tops of the posts were sawn off even and capped with bolted-on timbers. The back of the breakwater was stabilized with groins of wire mesh filled with rocks laboriously gathered from the lake bed along the shoreline. Wire cables anchored to stakes set back farther on shore provide additional vertical reinforcement. Most of this

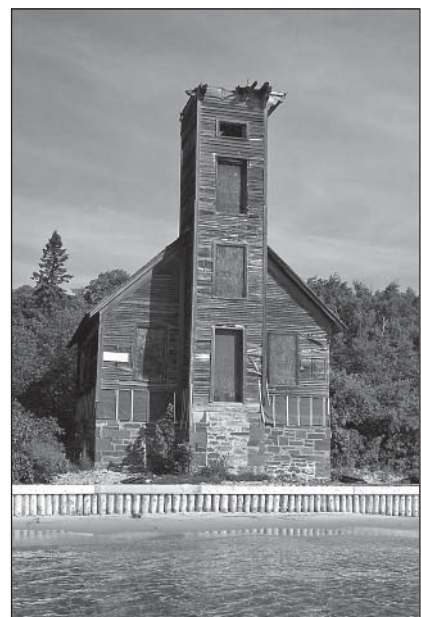
***Not so sexy "topless" view of Grand Island East Channel Light in 2003***

The top 12 inches of the tower, lantern deck, decorative wooden brackets, and lantern room were all beyond repair on site. These components were completely removed in the fall of 2002 and transported to Northern Michigan University in Marquette. There, students at the Jacobetti Vocational Training Center, part of the College of Technology and Applied Sciences, undertook a complete rebuild. The lower half or waist wall of the lantern room consisted of wood and had to be completely rebuilt as well. The original iron work of the upper half was reused. A new copper roof was installed on the lantern room by Pellow Roofing of Marquette. Missing for almost two years, the rebuilt top of the tower was bolted back into place late in August 2004. No window glass was installed in the lantern room in order to eliminate the worry of potential

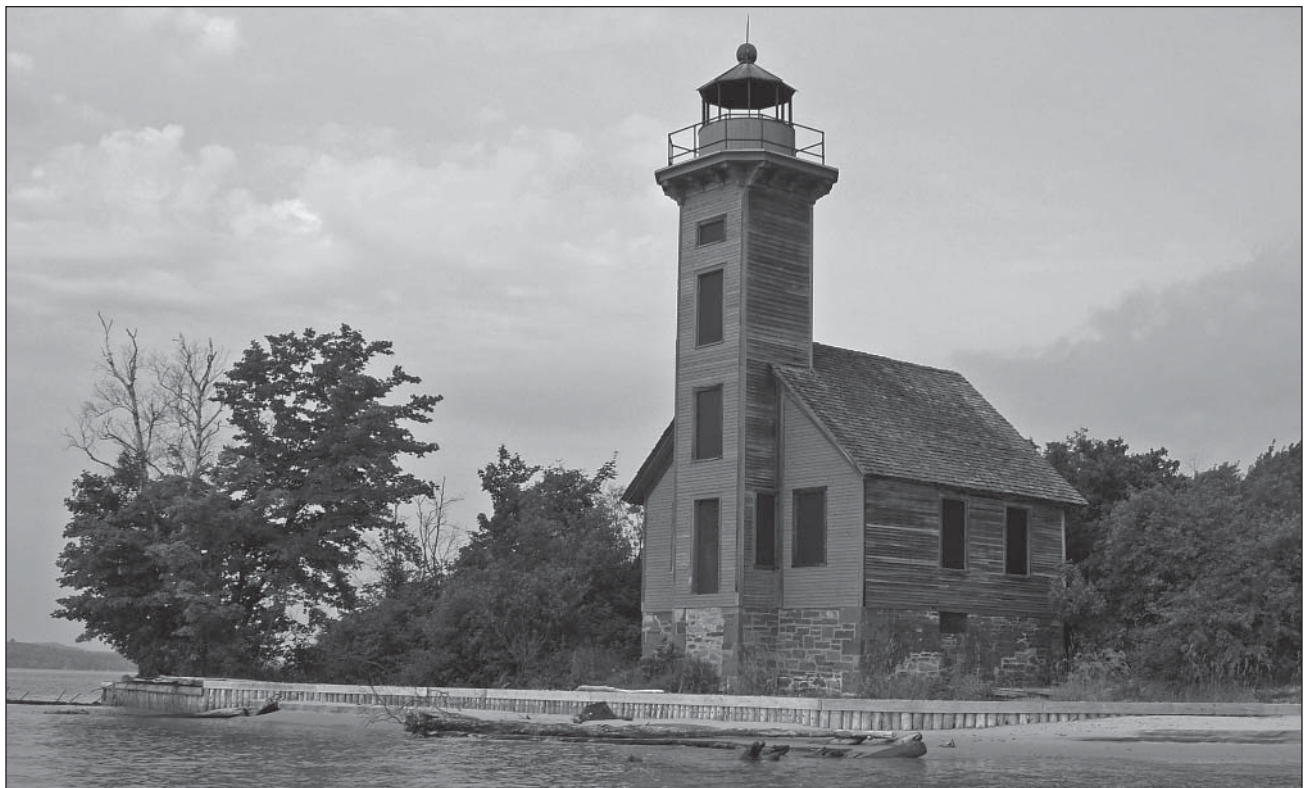
*Grand Island East Channel Light from the northeast, July 2005. Salvaged original siding was reused on the north side of the building, which accounts for the difference in appearance.*
